SUBJECT: Contract No. DE-AM01-07000LM00060, Stoller  
Task Order LM00-502, LTS&M – Other Defense Activities  
Transmittal of the September 2008 Fernald Site Inspection Forms  
Activity Code INS-1095

## FERNALD PRESERVE FIELD WALKDOWN INSPECTION FORM

**Fernald Preserve  
Consolidated Finding Locations  
for September 2008 Site Inspection**

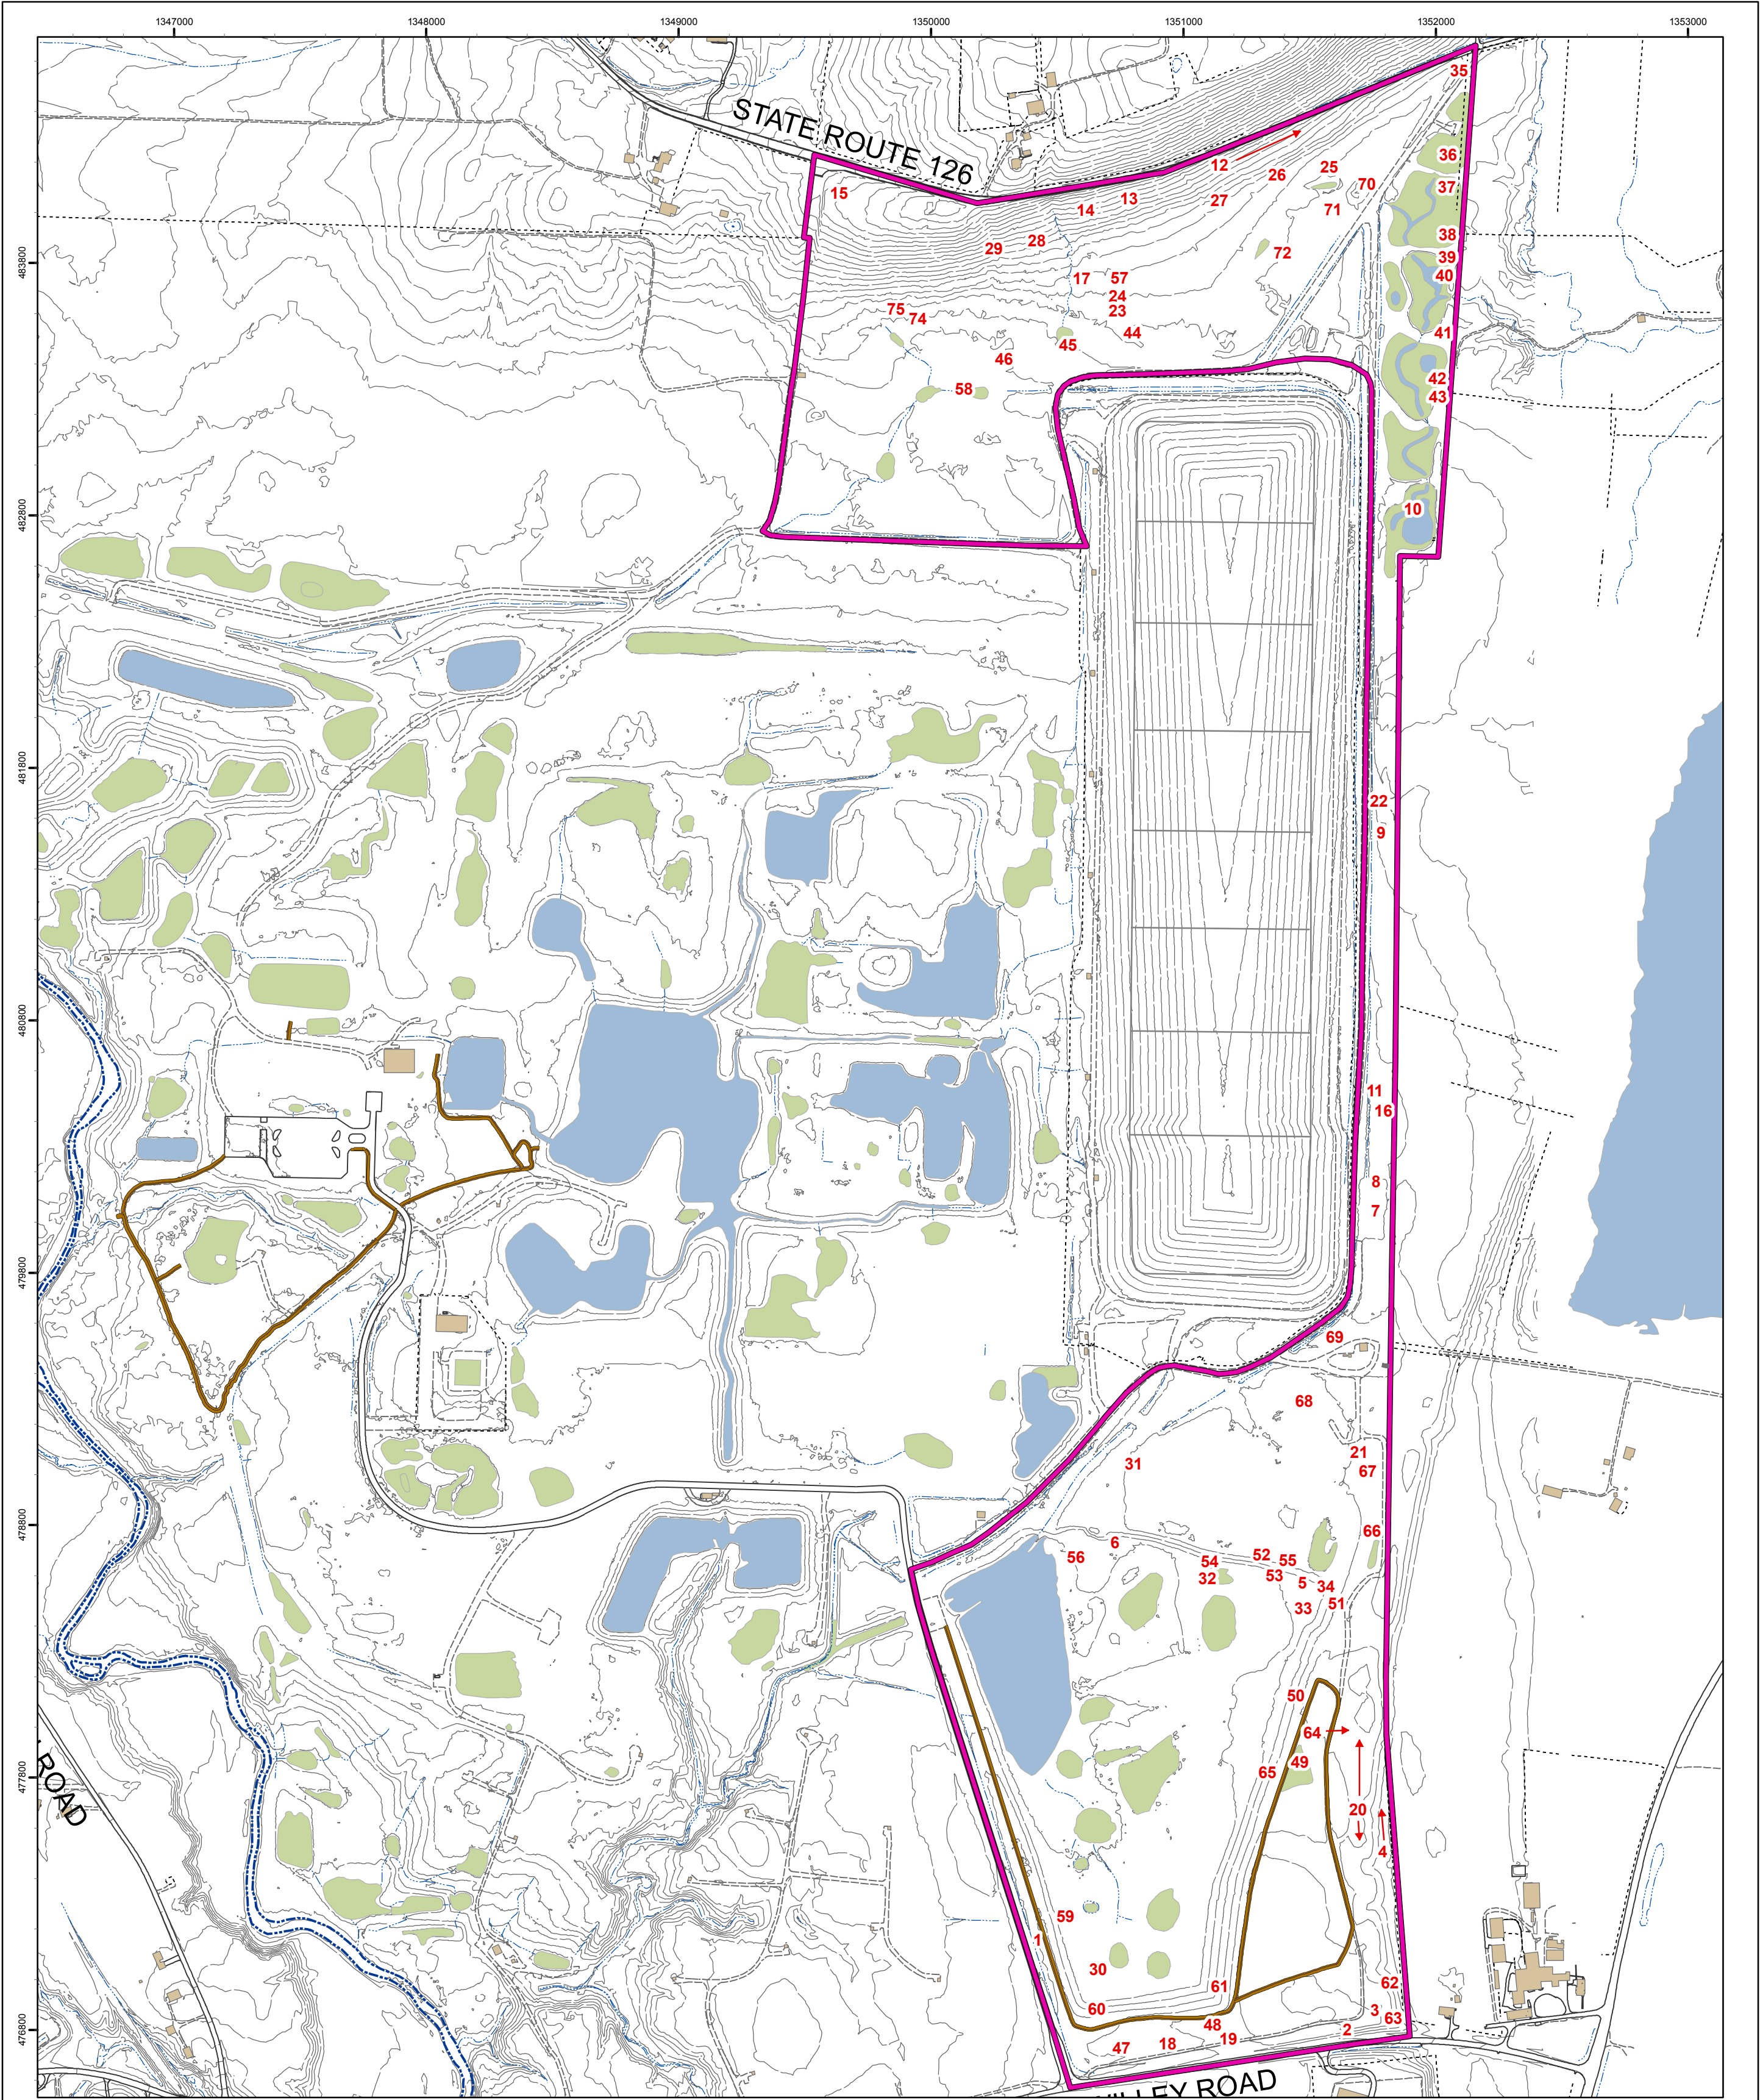
NOTE: Findings are numbered and provided on the September 2008 Field Walkdown Form.  
NOTE: Paddy's Run will be inspected as accessible - Summer/Fall.
